THREE-LAYER REPAIR COATING SYSTEM FOR MANHOLES, PUMP STATIONS, AND TANKS IN AGGRESSIVE SULFATE ENVIRONMENT

Tomasz PAWLAK¹, Anna SZYMCZAK-GRACZYK¹, Tomasz GARBOWSKI²

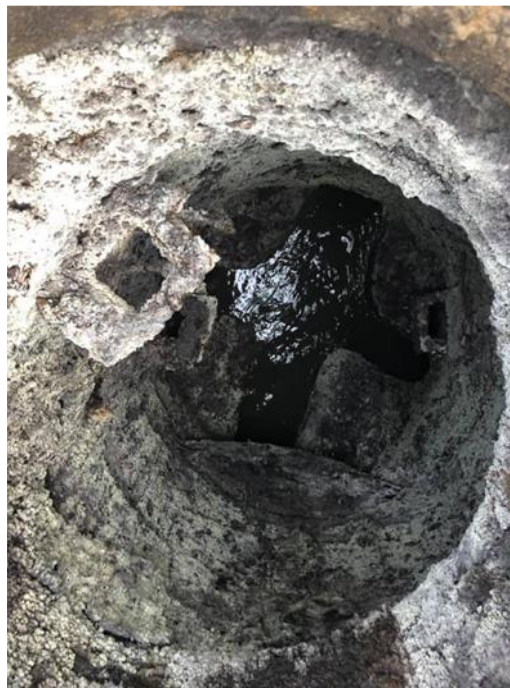
Lowered pH, in turn, leads to gradual reinforcement corrosion in reinforced concrete structures exposed to moisture. These are typical signs of sulfate corrosion, as shown in Fig. 1. Conditions conducive to sulfate corrosion usually occur in combined sewer systems and sanitary pipes. Pipelines, wells, and chambers with sediment accumulation and no ventilation are particularly susceptible. Expansion wells and gravity sections following pressure (pumping) pipes are especially vulnerable. In continuously operating pressure pipes, sulfate corrosion is often not observed, even with appropriate sulfur compound content in the sewage conveyed. It is believed that this is due to the short residence time of sewage. The real cause, however, is different (explained in [6]) – limited oxygen availability contributes, among other factors.

Fig. 1. Sulfate corrosion occurring in a sewer well

However, where it is worn by fast-flowing sewage (not formed), conditions for sulfate corrosion are generally not present. The damage formation zones in the sewer cross-section are shown in Fig. 1,

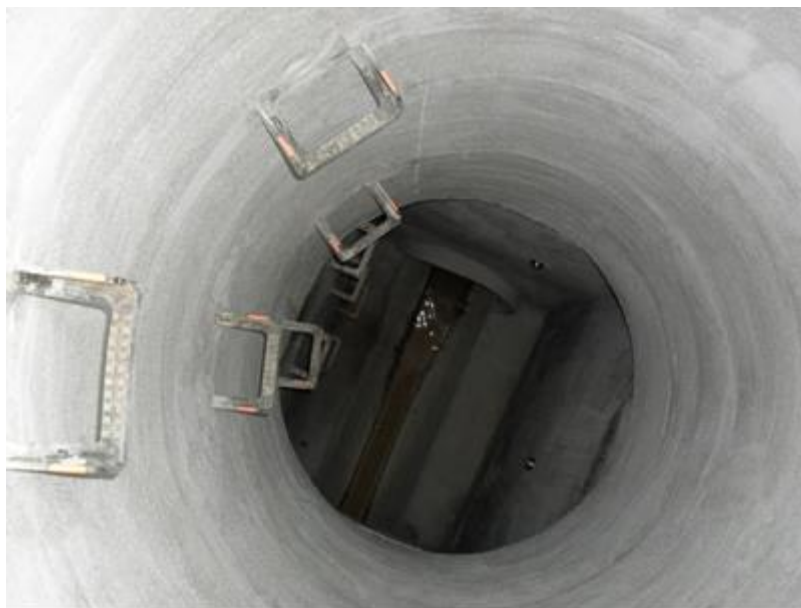
Fig. 2. Renovation method of manholes using construction chemistry

In cases of sulfate corrosion threat, several methods are used to protect concrete structures, including coating protections made from cement-based materials (Fig. 2), resins (Fig. 3), GRP (TWS) liners made of polyester resins (Fig. 4), PE panels – polyethylene elements welded during installation, and various ready-made elements such as polymer concrete modules (Fig. 5) or finished polyurea

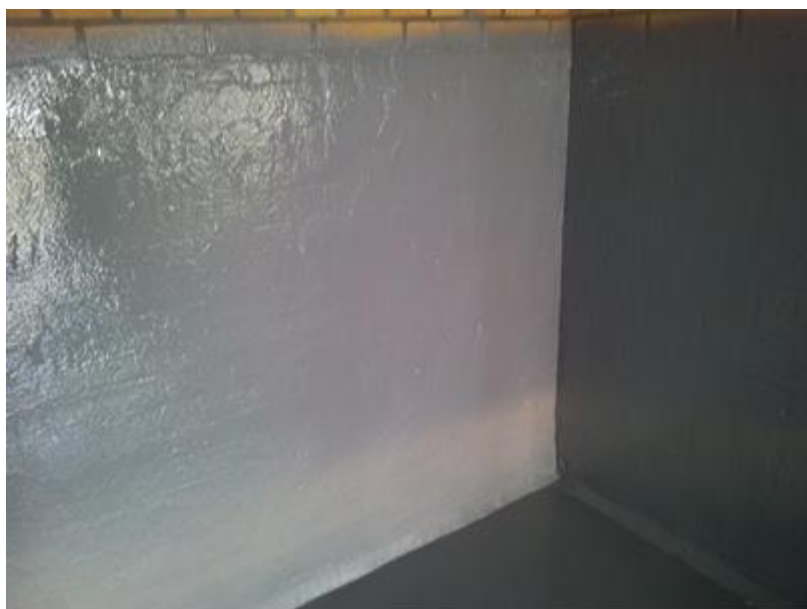
Fig. 3. Renovation method using resins

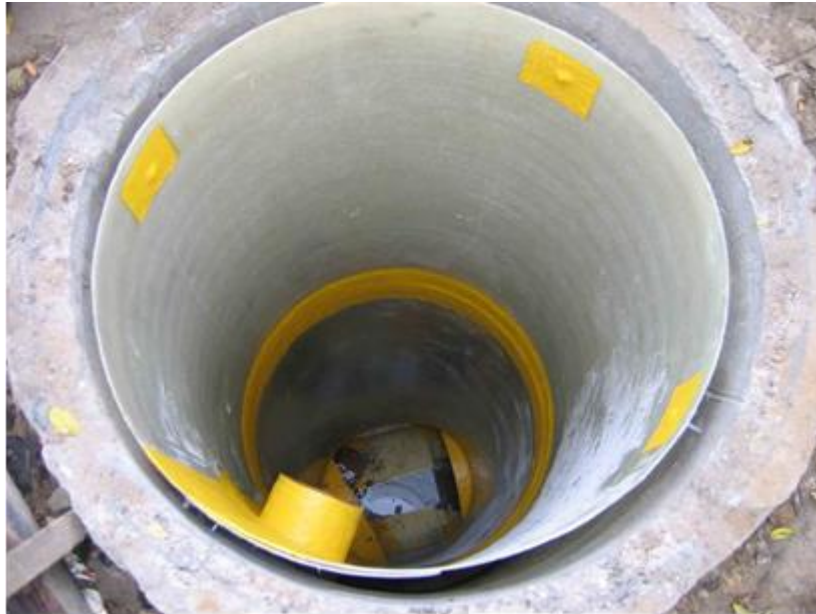
Fig. 4. Renovation method using GRP (TWS) liners

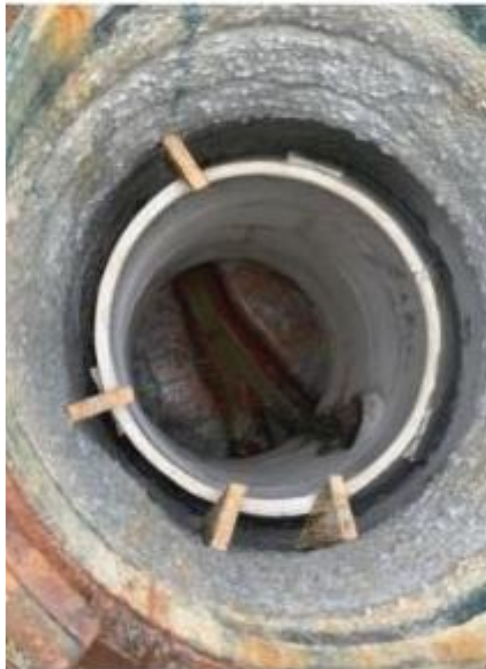
Fig. 5. Renovation method using polymer concrete modules [47]

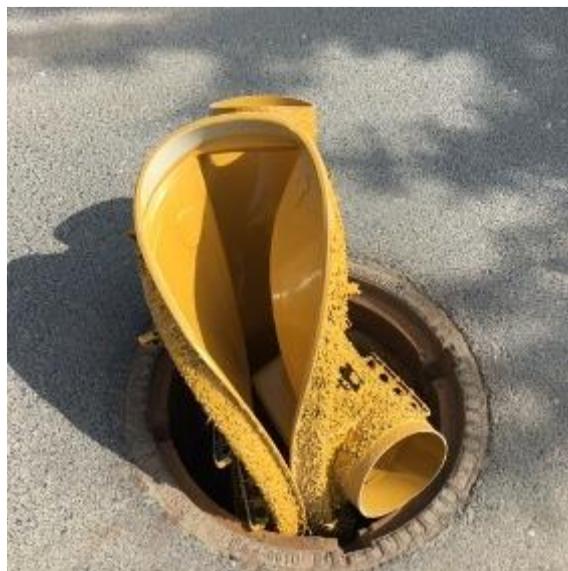
Fig. 6. Renovation method using polyurea liners [48]

elements (Fig. 6). This article presents a comparative analysis of these methods against the method of three-layer membrane spraying as an alternative to traditional renovation methods.

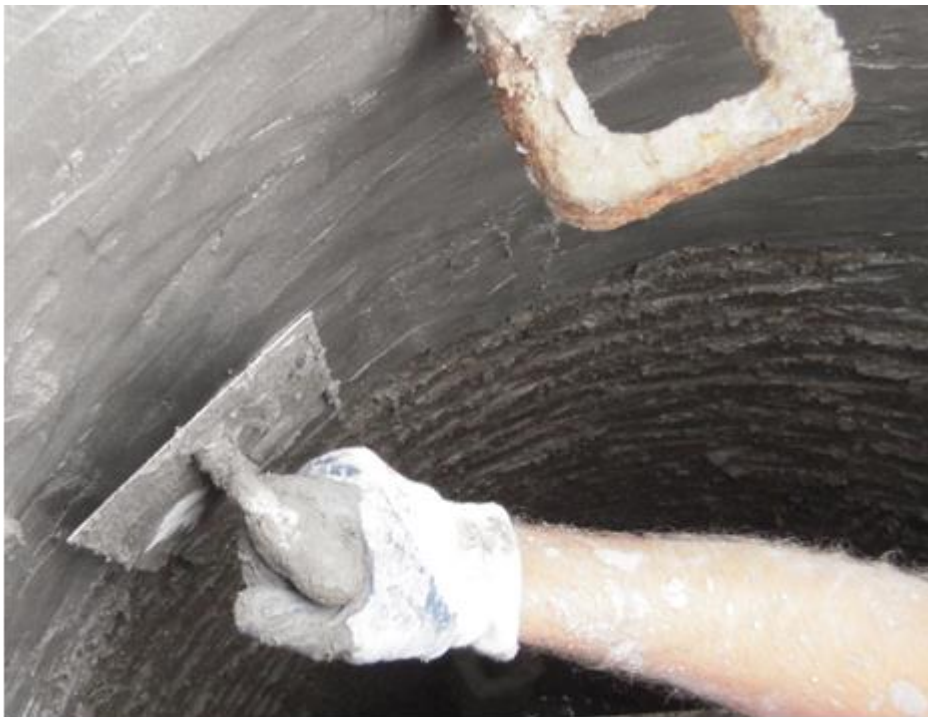
The traditional method of renovation using polyurea spraying involves applying a cement-based material to restore the corroded structure and as a layer that smooths the surface after cleaning (Fig. 7). This is also the final stage in the renovation of concrete surfaces using construction chemicals, which often does not yield satisfactory results. After the polymer-cement material has cured, the drying process follows, and then a resin primer is applied, and finally, polyurea is sprayed. Unfortunately, this process is time-consuming and carries a significant risk of unwanted effects. Although the polyurea material cures in a few seconds, the curing time of the restorative mortars can take up to two weeks, and water trapped in the concrete structure can lead to the formation of blisters and delamination of the polyurea membrane.

Fig. 7. Restoration of the corroded surface with cement-based materials

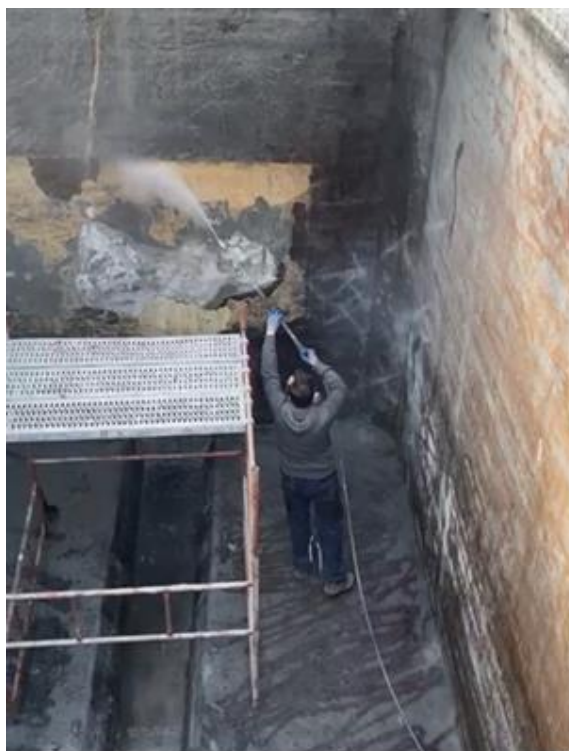
The surfaces to be repaired should be free of dust, soot, oils, greases, release agents, etc. The preparation of the concrete substrate involves removing the old coating down to the "healthy" layer. This should be done using mechanical methods such as chiseling, stripping, or sandblasting. After removing the old coatings, a hydrodynamic method should be used. In this method, water at a pressure of approximately 50-150 MPa (with a stream length of 1-6 cm) removes a surface layer of 1-3 mm thickness. This results in a rough, clean, and moist surface, free of microcracks (water at such pressure ruptures microcracks; ensure proper drainage of this water from the object). If reinforcing steel is present and exposed after cleaning, it should be cleaned using an abrasive blast method to a cleanliness class of at least Sa2. The concrete cover around the reinforcing steel should be chipped away to a non-corroded area. The cleaned bars should not be left uncovered; they must be coated with a specialized anti-corrosion mortar (Fig. 8).

Fig. 8. Hydrodynamic cleaning

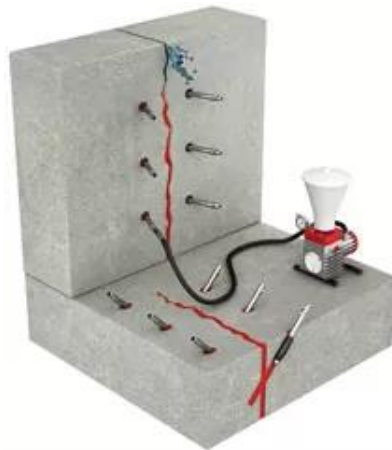
After cleaning the structure, it may turn out that the tank, manhole, or pumping station has leaks, shrinkage cracks, or structural cracks that need to be sealed and reinforced. Currently, successfully used reinforcement techniques (e.g., injections, or bonding carbon tapes/mats) and protective preparations can improve the condition and stop destructive processes (Fig. 9).

Fig. 9. Pressure injection of cracks

- Fill cracks with injections and additionally reinforce with special reinforcement to prevent further widening, using available sealing and waterproofing systems.
- Additionally reinforce crack areas with extra reinforcement (e.g., mesh, or bonding carbon mats/tapes) from the inside of the tank.

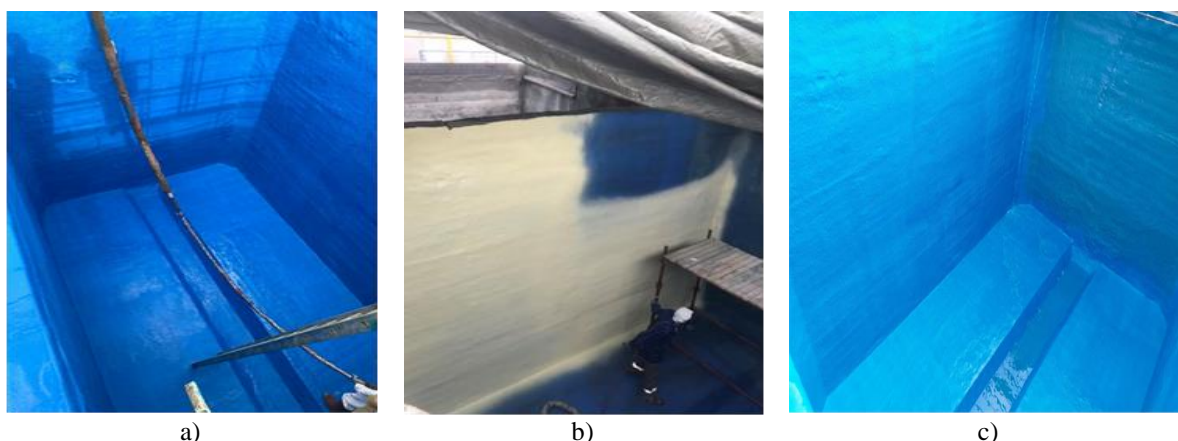
The prepared, injected, and dried substrate is covered with a polyurea membrane using a specialized spraying machine to achieve a uniform surface. The polyurea membrane base layer will serve as a moisture barrier for the structure. Additionally, this layer will ensure complete impermeability of the concrete surface to the aggressive environment (Fig. 10a).

To apply the repair and reprofiling layer to the structure walls, use rigid polyurethane with a density of at least 80 kg/m^3 and up to 120 kg/m^3 with a diffusion resistance coefficient above 200 to ensure adequate rigidity combined with high flexibility. This process should be carried out using a specialized spraying machine. The rigid polyurethane is intended to reinforce the base layer of the previously applied moisture-blocking polyurea. The thickness of the layer can be applied from 0.5 cm up to several centimeters, depending on the thickness of the corroded layer of the reinforced concrete structure (Fig. 10b).

After completing the above steps, the prepared substrate should be coated again with polyurea. Using specialized equipment (Reactor), apply the anti-corrosion and sealing layer of Polyurea 100% using a spray method at 150-240 bar. The polyurea membrane was selected due to the environment in the

chambers and the necessity of using a material suitable for contact with potable water – membrane parameters are provided below. The structure can be loaded with water a few minutes after the coating application (Fig. 10c).

Fig. 10. Steps of preparation of the Three-Layer Polyurea Coating System, a) base layer of polyurea blocking moisture, b) repair and reinforcing layer (rigid polyurethane), c) final protective layer
